# Manhole Inspection Summary

Manhole # S27I\_\_002MH

Insp Date: **1/16/09 1:03 PM**

**Location** Address: **S.Amity St.**

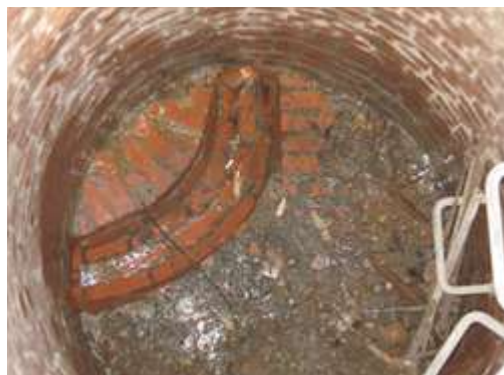
Top View

note debris on bench and in rungs

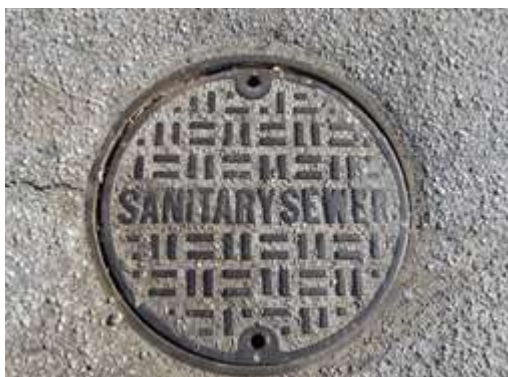
MH Lid

too small for MH

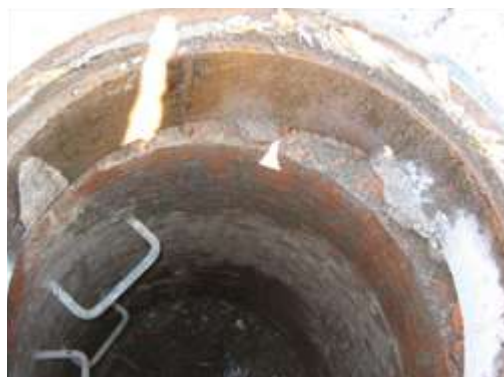
Defect 8

**Frame** Offset: **3** (in.) Condition: ☒ Sound ☐ Cracked ☐ Leaks

Infiltration: ☐ None ☒ **Joint** ☐ Cracks ☒ **Mortar** ☐ Roots ☐ Wall

frame offset, chimney joint infiltration

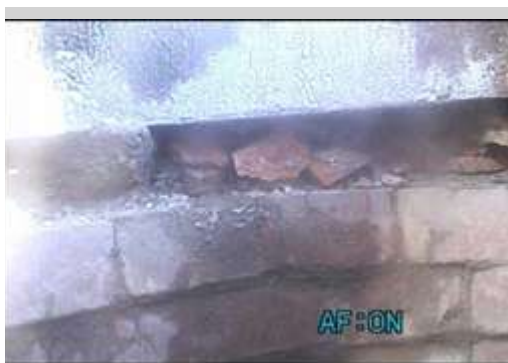
Defect 5

Condition: ☐ Sound ☐ Cracked ☐ Root Intrusion ☒ **Loose Brick** ☒ **Deteriorated**

deteriorated chimney with loose brick & infiltration from mortar

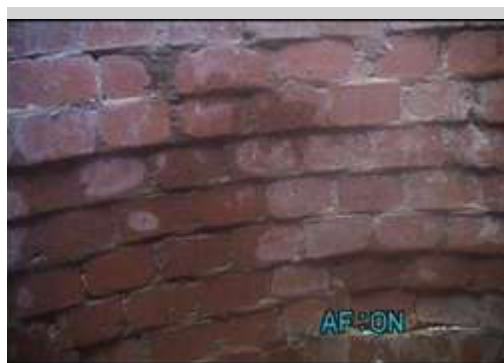
Defect 4

Infiltration: ☐ None ☐ Joint ☐ Cracks ☒ **Mortar** ☐ Roots ☒ **Wall**

corbel infiltration from wall & mortar

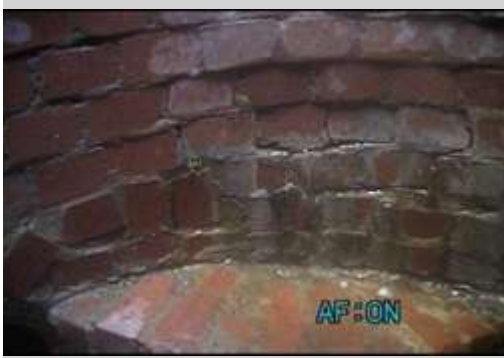
Defect 1

Condition: ☐ Sound ☒ **Cracked** ☐ Root Intrusion ☐ Loose Brick ☐ Deteriorated

Infiltration: ☐ None ☐ Joint ☒ **Cracks** ☐ Mortar ☐ Roots ☐ Wall

barrel cracked with active infiltration from cracks

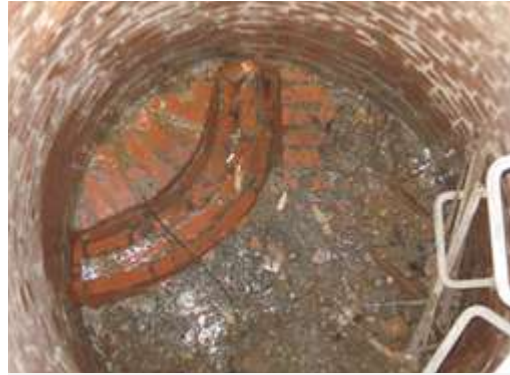
Defect 6

Condition: ☐ Sound ☐ Cracked ☐ Root Intrusion ☐ Deteriorated ☐ Leaks ☒ **Debris**

debris on bench and in rungs

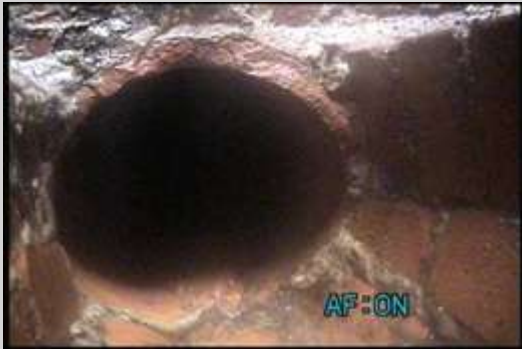
12 O'Clock Outflow

Pipe Height: **8.4** (in.) Rod and Bar (Angled)  
Pipe Material: **Clay** ☐ Pipe Lined  
Invert Depth: **9.84** (ft.) Flow Characteristics: **Slow**  
Deposits: ☒ None ☐ Mud ☐ Sludge ☐ Debris ☐ Grease  
Silt Depth: **0** (in.) Deposits Extent:  
Infiltration: **None** Pipe Seal Cond: **Broken**
